Manhole Inspection Summary

Manhole # S51E__031MH

Insp Date: **5/13/08 8:58 AM**

Location Address: **2901 e baltimore st**

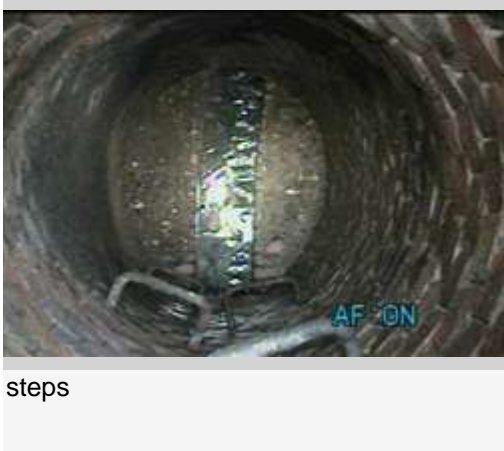
Defect 1

Condition: ☐ Sound ☐ Cracked ☐ Root Intrusion ☐ Deteriorated ☐ Leaks ☒ **Debris**

Steps Count: **5** Missing: **1** ☒ **Corroded**

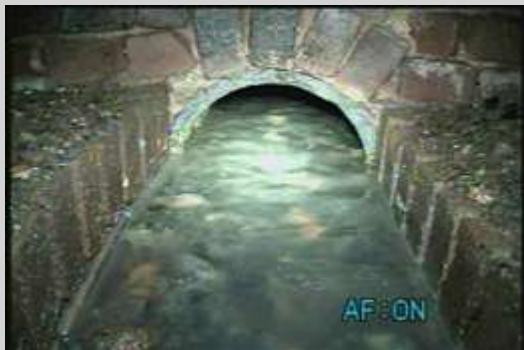
12 O'Clock Outflow

8 in. Circular Gravity Sewer
Pipe Out @ 12 O'Clock

Pipe Material: **Clay** ☐ Pipe Lined

Invert Depth: **10.08** (ft.) Flow Characteristics: **Fast**

Deposits: ☒ None ☐ Mud ☐ Sludge ☐ Debris ☐ Grease

Infiltration: **None** Pipe Seal Cond: **Unknown**

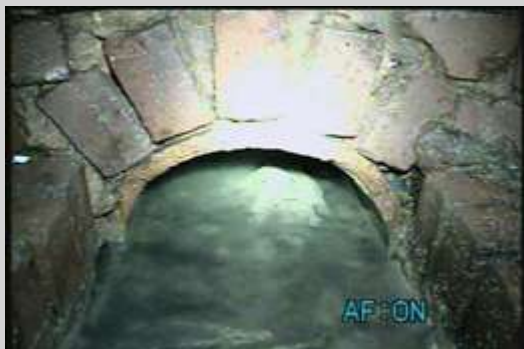
6 O'Clock Inflow

10 in. Circular Gravity Sewer
Pipe In @ 6 O'Clock

Pipe Material: **Clay** ☐ Pipe Lined

Invert Depth: **10.00** (ft.) Flow Characteristics: **Fast**

Deposits: ☒ None ☐ Mud ☐ Sludge ☐ Debris ☐ Grease

Infiltration: **None** Pipe Seal Cond: **Unknown**
